# **Damage mechanisms and non-destructive testing in the case of water ingress in CF-18 flight control surfaces**

Technical Memorandum

DCIEM TM 2000-098

August 2000

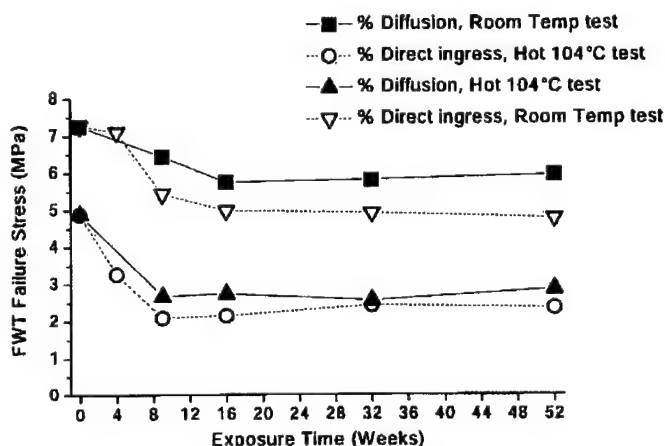
Immersion of aluminum joints in water or exposure to high humidity normally leads to a substantial loss in joint strength, but exposure to moderate humidities for long periods does not normally lead to permanent strength loss [9]. Hence, this effect is relatively unimportant compared with environmentally induced loss of adhesion at, or close to, the metal oxide/adhesive interface due to water ingress. Although the difference between the strength for direct ingress and diffusion ingress specimens is not great when wet/moist (Figure 4), the failure mode is fairly different. After long-term exposure, the diffusion ingress samples show cohesive failure in all cases (i.e., through the adhesive) while direct ingress samples failed at the adhesive to core interface [3].

Figure 4. FWT test results for direct moisture ingress and diffusion moisture ingress tested under room temperature and 104°C test conditions from [3].

This difference in the degradation mechanisms between diffusion and direct ingress cases is supported when considering the dry recovery of the specimens (Table 1). The diffusion specimens recover much of their original properties which indicates that reductions in Flatwise Tension (FWT) strength are due to moisture in the adhesive causing plasticisation and not due to any permanent degradation of the adhesive bond. On the other hand, the direct ingress specimen did not recover their full FWT strength. This loss of strength indicates that some level of permanent adhesive bond degradation has occurred [3].

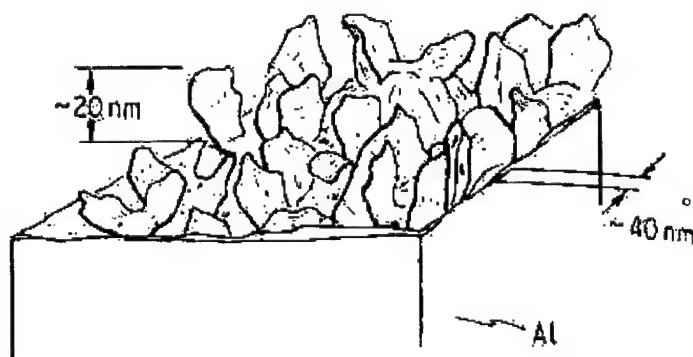
Weakening of the oxide by hydration involves permeation of water through the adhesive, hydration of the oxide and cleavage of the mechanically weak hydrated oxide [11,24,25]. Specifically, water initially passivates the oxide film and protects the metal from attack during an "incubation" period. The intense hydration activity will convert the original oxide to a hydroxide. It is the hydration of aluminum oxide on the adhesive/adherend interface that likely plays an important role in joint failure. Venables [26] found that pseudo-boehmite (Figure 5) may be created by the reaction

Figure 5. Characteristic "cornflake" structure associated with pseudo-boehmite morphology from [9].

The conversion of aluminum oxide to hydroxide is accompanied by a threefold increase in thickness, and the adhesion of the hydroxide to aluminum is sufficiently weak that once the hydroxide forms, it separates from the adherend and leads to bond failure. Experiments [26]
